## Legionella Risk Assessment

Risk Assessment Date – 5<sup>th</sup> May 2015  
Recommended Review Date – May 2017

## **Legionella Risk Assessor – Kevin Dempsey**

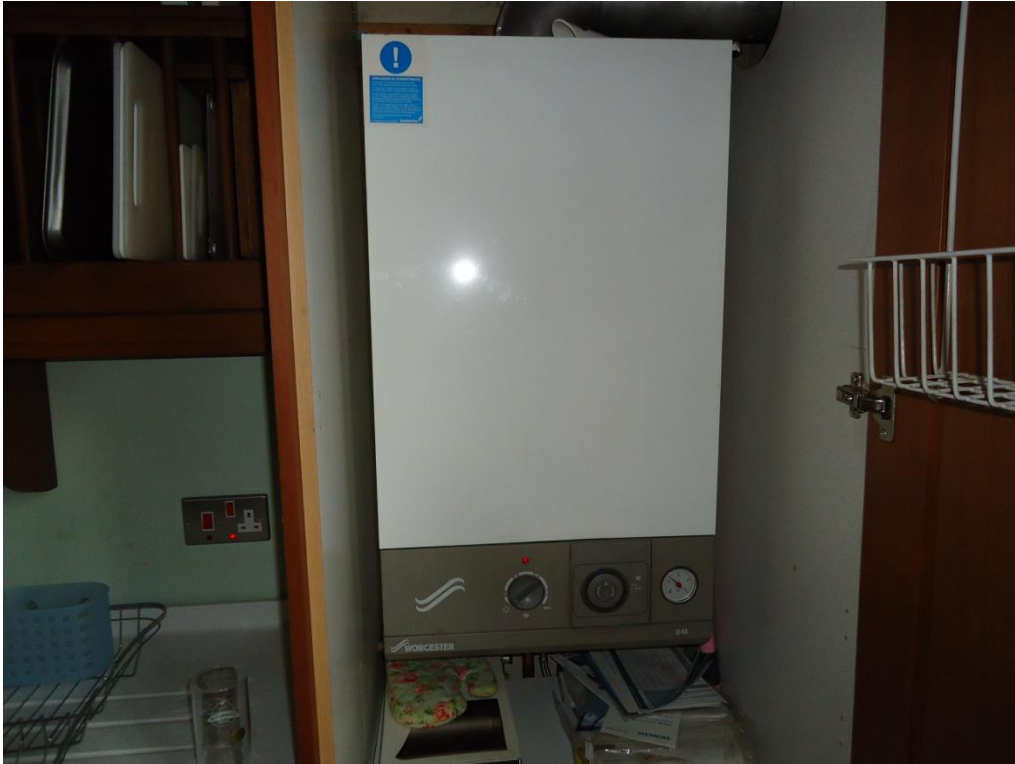
The property has a direct fired gas combi boiler which heats the town mains water instantaneously before delivering it to the hot water outlets. Combi boilers are considered low risk items of hardware in terms of legionella risk due to their direct cold water mains supply and minimal storage of hot water. The combi boiler should be maintained within the annual gas safety service inspection.

Combi boiler

At the time of the inspection the hot water temperatures in the property were recorded as being below 50°C. This was due to the combi boiler not igniting correctly, and not providing hot water. Recommend that the temperature of the hot water be checked after the combi boiler has been repaired to confirm that water is being heated to above 50°C.

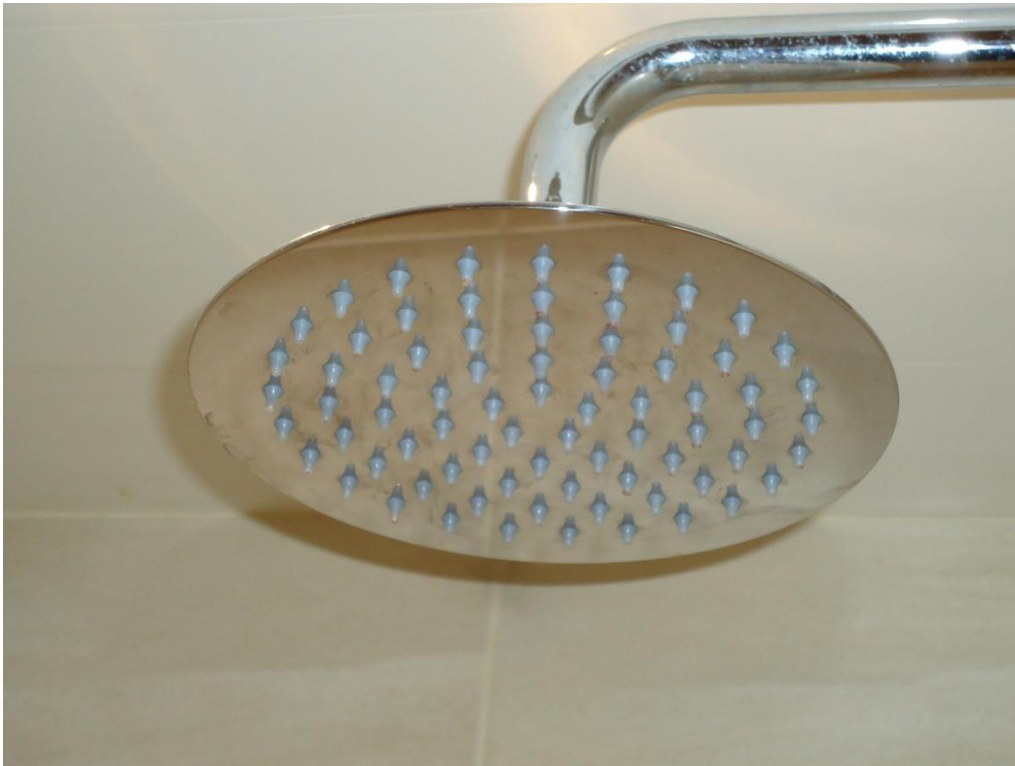
Bathroom shower head

Dismantle, clean and descale removable parts, heads and hoses where fitted on a quarterly basis or as indicated by the rate of fouling.
